BALTIC MILLS DAM
NH 00273

PHASE I INSPECTION REPORT
NATIONAL DAM INSPECTION PROGRAM

FEBRUARY 1979

Identification No.: NH00273
Name of Dam: Baltic Mills Dam
Town: Enfield
County and State: Grafton County, New Hampshire
River: Mascoma River
Date of Inspection: November 8, 1978

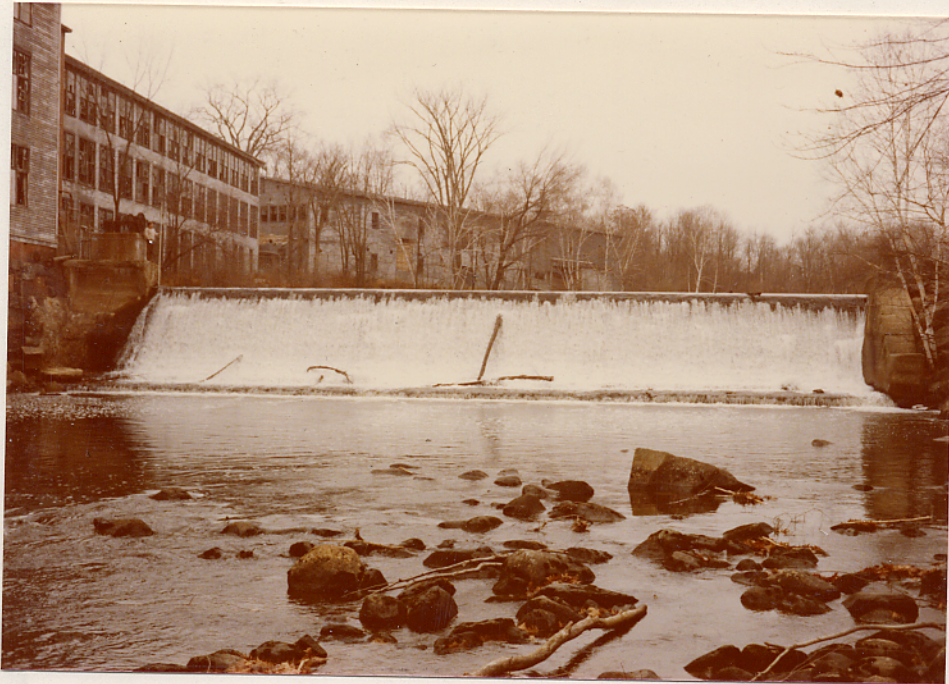
b. Dam. Baltic Mills Dam is a concrete-gravity dam with an ogee downstream face about 17 feet high and a spillway section about 96 feet long. (See Appendix C - Figure 2.) At the time of the inspection, several inches of water were flowing over the crest of the dam. To the extent that the downstream face of the dam was visible beneath the water flowing over the dam, no obvious defects were observed in the concrete. The upstream face of the dam was not visible beneath the reservoir surface.

To the extent that it was visible beneath the overflowing water, the main section of the concrete dam exhibited only one obvious defect which is discussed in the following paragraph. Otherwise, the dam appeared to be in good condition. This tentative evaluation should be verified by an inspection of the dam when no water is flowing over the crest.

Figure 2 - Looking east at downstream face of dam.

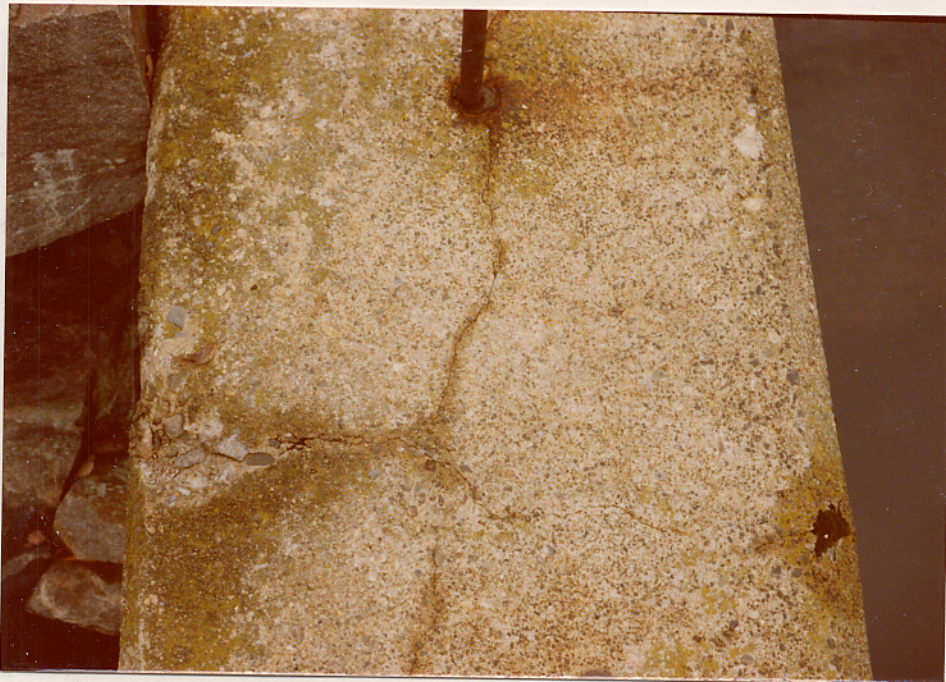
At the south end of the dam a concrete training wall extends upstream and downstream from the dam. The training wall is cracked in several places. (See Appendix C - Figure 3.) Between this training wall and the natural ground of the south abutment is a dumped rockfill which consists of boulders ranging from 2 to 4 feet in length. (See Appendix C - Figure 4.) A small amount of sand-and-gravel-sized crushed rock has been dumped on part of the surface of the rock fill. The rockfill has little or no vegetation on its surface.

The training wall at the south end of the dam is cracked in several places.

(2) Cracking of the training wall at the south end of the concrete spillway section of the dam.

(2) Cracking of the training wall at the south end of the concrete section of the dam.

Figure 3 - Looking at cracks in top of training wall at south abutment.

(1) Recommend repairs for the deteriorated concrete in the gate structure and the north end of the concrete section of the dam and for the cracked training wall at the south end of the concrete section of the dam.

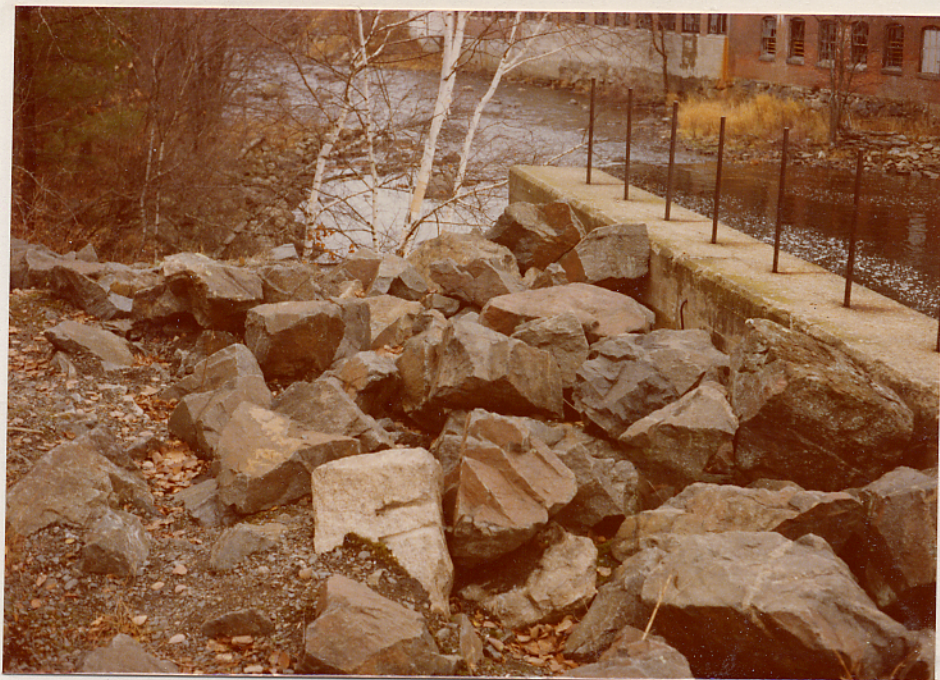
Beyond the south abutment is a railroad which runs along the valley. Available records indicate that the rockfill embankment between the dam and the railroad was "badly washed away" during a flood in September 1938. It appears that rockfill was placed to repair the eroded part of the embankment. No seepage was observed at the south abutment.

The earthen embankment section between the south end of the dam and the south abutment could be susceptible to erosion, because of a lack of vegetation. No seepage discharge was observed at the south abutment.

Figure 4 - Looking at rock fill placed between south abutment training wall and natural ground.

(2) Evaluate the embankment at the south end of the dam with respect to erosion resistance if it should be overtopped, and to recommend remedial measures, if needed.

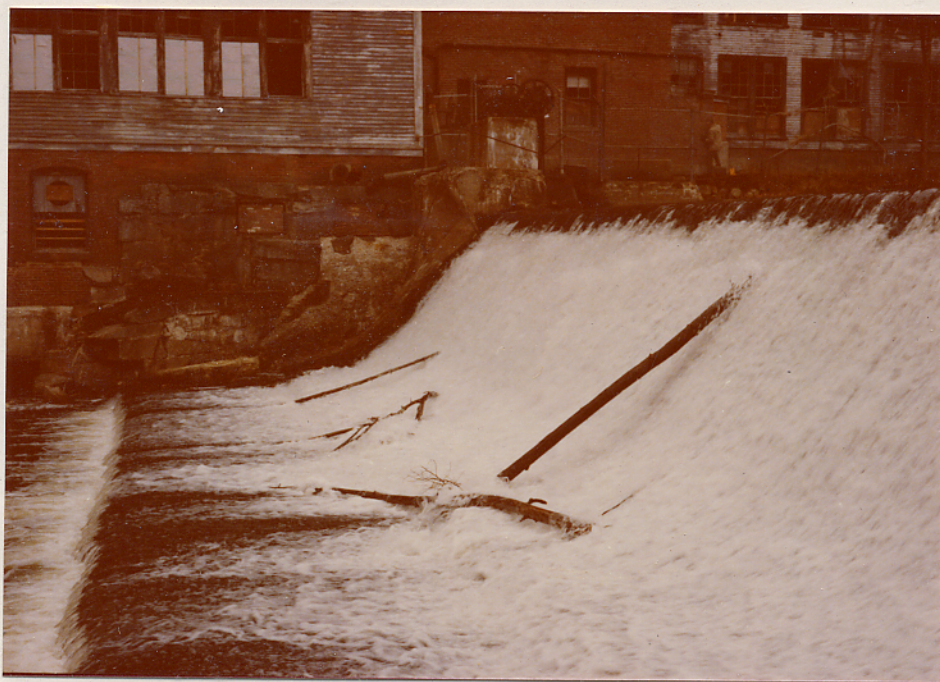
The north abutment of the dam was accessible on a subsequent inspection. The concrete in the gate structure and in the dam itself near the north abutment is badly deteriorated. (See Appendix C - Figures 5 and 6.)

Based on the visual inspection, the Baltic Mills Dam is in fair condition. The concrete surfaces of the gate structure and dam near the north abutment are badly deteriorated.

(1) Deterioration of the concrete in the gate structure and in the dam itself near the north abutment.

Figure 5 - Looking north across downstream face of dam at mill building and drain gate structure.

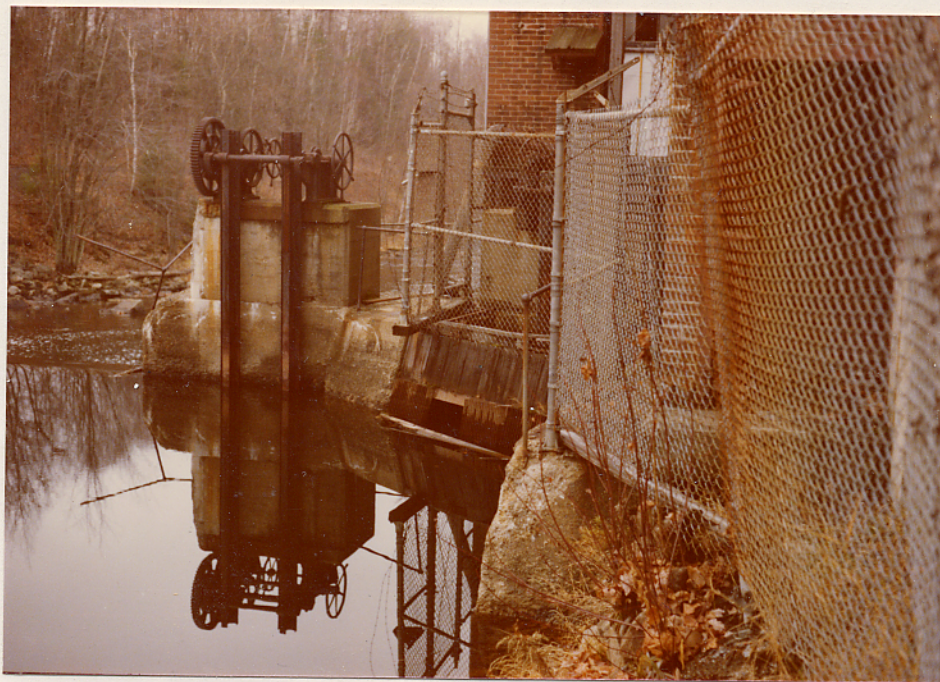
c. Appurtenant Structures. The outlet works are located on the north abutment and are an integral part of the dam and the adjacent building. (See Appendix C - Figure 6.) The concrete surfaces of the outlet works have spalled up to 2 inches in depth. Cracks and effloresced areas in partial contact with water show the most erosion. One large piece (approximately 1 cy) of concrete was observed lying on the downstream apron. Visual inspection did not determine the concrete's original location. The condition of the gate could not be determined. However, some leakage was observed at the downstream outlet. The mechanical gate operating mechanism was in fair condition.

Figure 6 - Looking at inlet to penstock and control to drain gate located on north abutment.
